A LETHAL COMBINATION

*Real-world examples of why
electricity and water don't mix*

From the EC&M e-books library

Pool Shock Peril Resurfaces

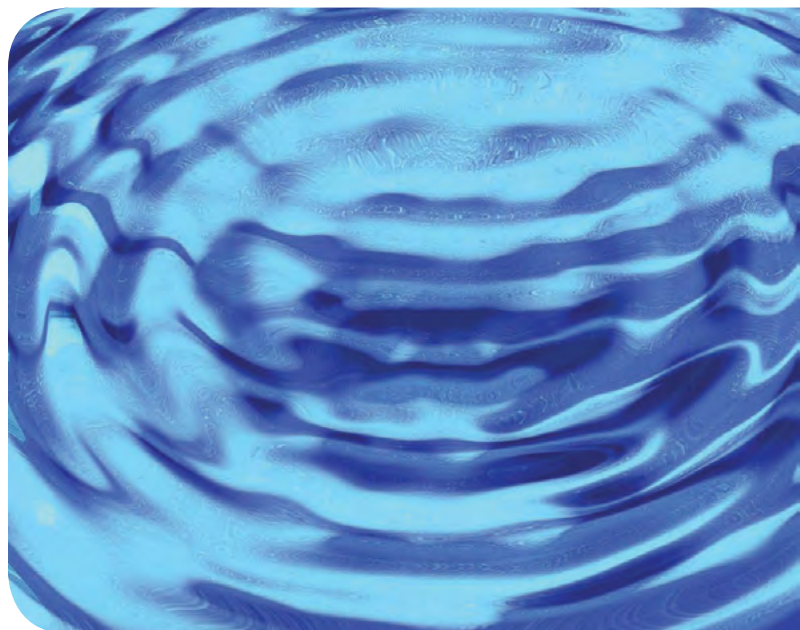
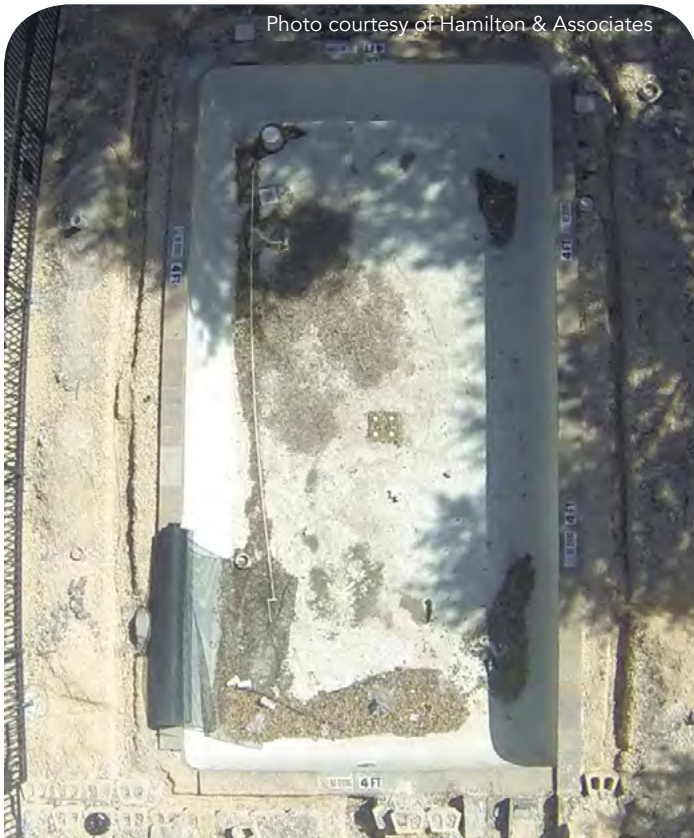
Photo 1. This aerial photo shows a pool being rebuilt and brought up to current Code requirements at the time. The equipotential bonding ring for the perimeter surface is located in the trenches encircling the pool. This ring is installed in the subgrade under the perimeter deck surface (in this case, pavers).

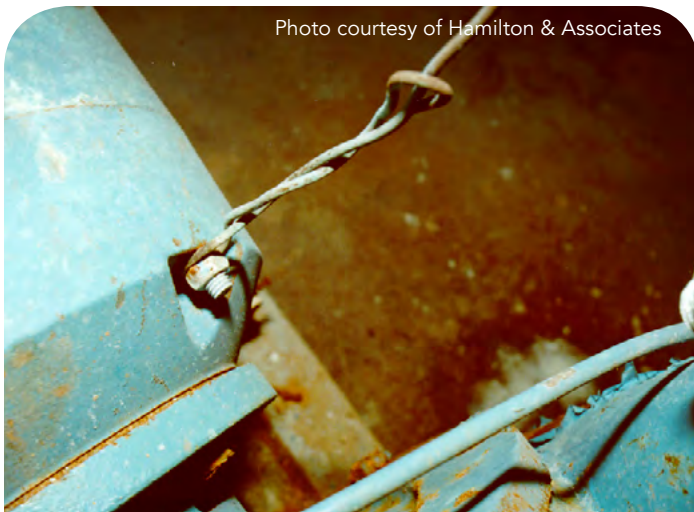
Photo 2. This image shows an improper attachment of a bonding wire to a pump motor at a large competition pool. The bonding wire should be installed with a suitable connector.

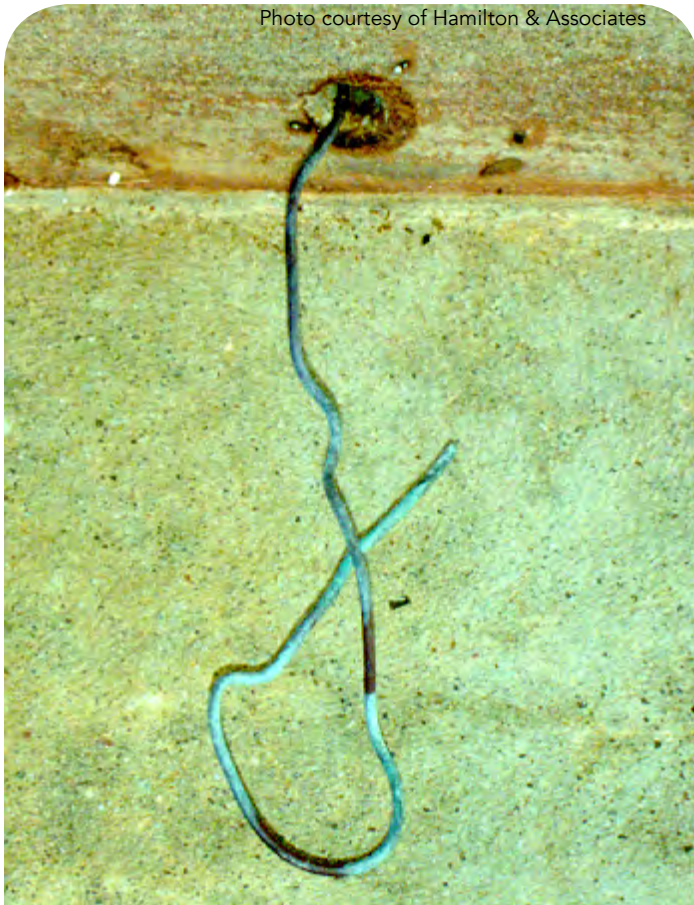
Photo 3. This bonding wire from an underwater pool light (seen from the back side of the pool structure) is not connected to the equipotential bonding grid.

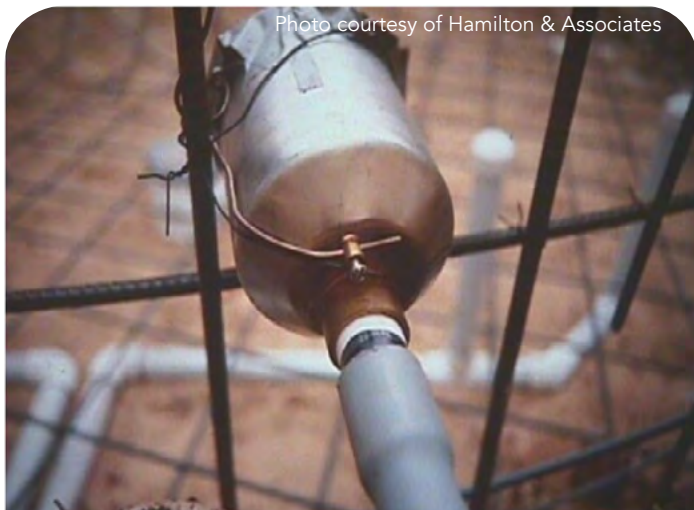
Photo 4. Proper installation of a bonding conductor from the back of a metallic light niche to a listed clamp (not in photograph) attached to the pool structural steel. Because the conduit is non-metallic, a second No. 8 AWG wire must be run from the lug on the interior of the niche to the ground bus in the junction box, power supply, or transformer enclosure serving the light; the connection inside the niche must be potted with a suitable listed potting material.

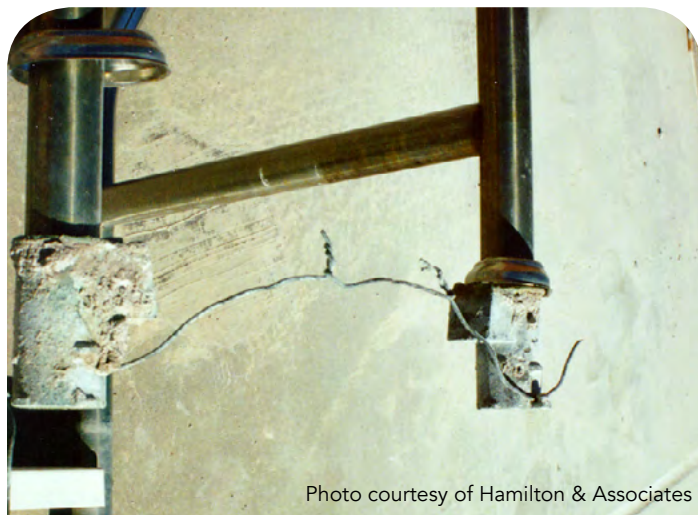
Photo 5. Pool ladder pockets must be bonded, but not this way. There is no assurance of electrical continuity because of the twisted connections. This was discovered upon excavation and illustrates the need for vigilance and frequent observations during the construction process.

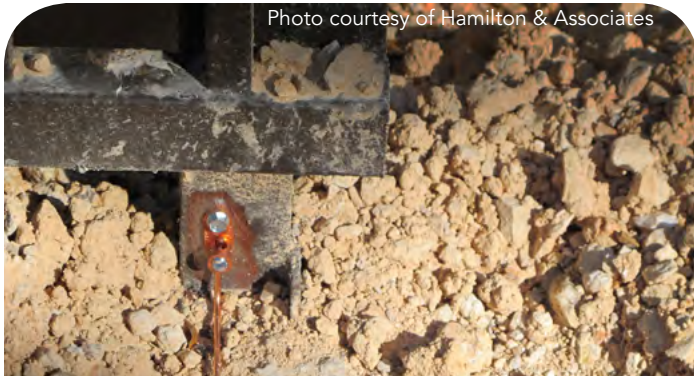
Photo 6. All metallic fences within 5 ft of the inside wall of the pool must be connected to the equipotential bonding grid. In making these and other connections subject to direct burial, listed devices suitable for direct burial must be used, and it is important that attachment screws be made of stainless-steel or other corrosion-resistant material.

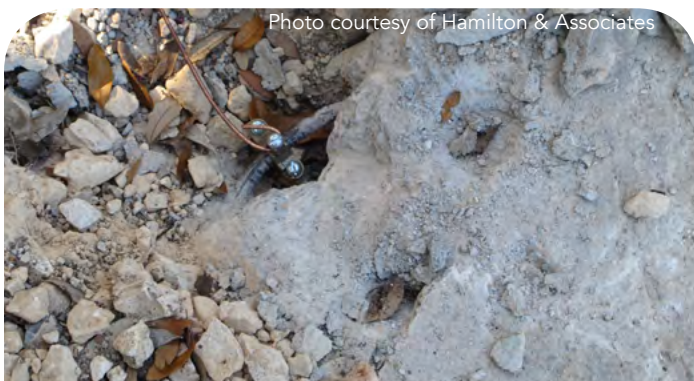
Photo 7. This photo shows an improper connection of the bonding ring to the pool's structural steel. Plated steel screws, even in listed devices, generally will not last in a corrosive pool environment.

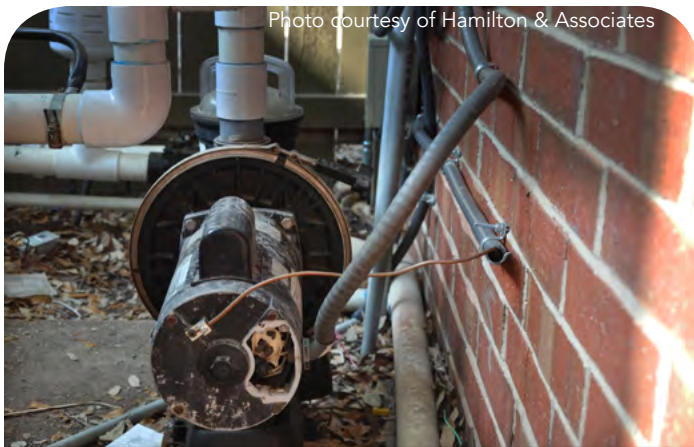
Photo 8. The bonding system extends back from the pool to the equipment pad. This photo shows a proper bonding connection at the pump motor, prior to the wiring compartment cover being installed.

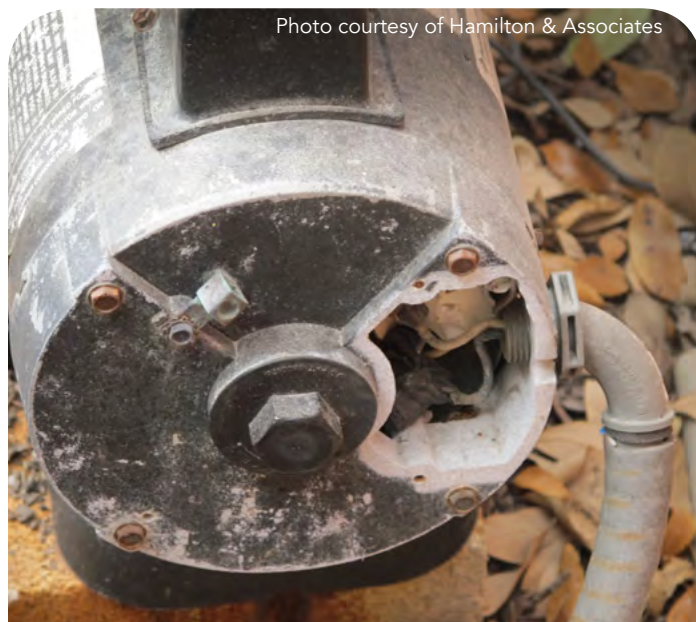
Photo 9. This image shows a pool pump motor prior to attachment of the bonding conductor to the lug at the upper left. The wiring compartment cover is open and also must be installed to provide a safe and Code-compliant installation.

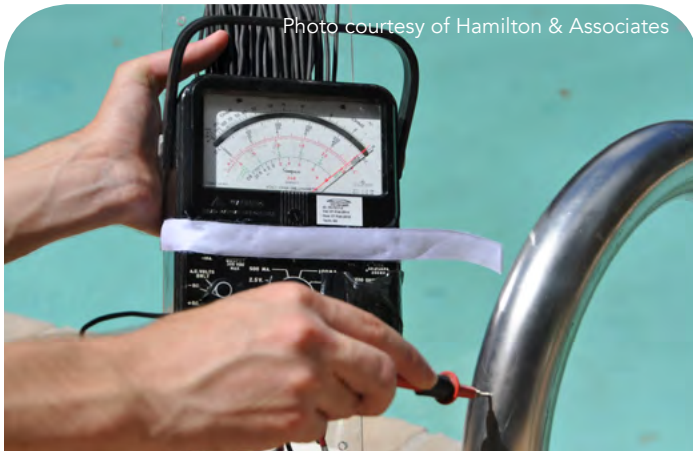
Photo 10. To verify the integrity of the bonding system, test it. Some states require periodic testing for commercial pools. This is basically a continuity test among items required to be bonded by the Code, and should be done so that the current being injected flows through the pool structural steel (concrete pools) and the perimeter bonding ring (non-conducting pools) such as fiberglass and vinyl liner pools. Plus, there are some things that old technology still does better, and this is one of them. Analog meters with large (C or D cell) batteries, an integral polarity reversal switch, and a “zero ohms” function allow the user to verify bond integrity over long distances and to detect if DC ground currents are affecting the measurement. More than 20 years of testing indicates that properly bonded equipment will exhibit resistances generally well less than 1 ohm, while ineffective bonds will measure substantially greater than 1 ohm. Equipment with current calibration (white label in the photo) should be used for these measurements.

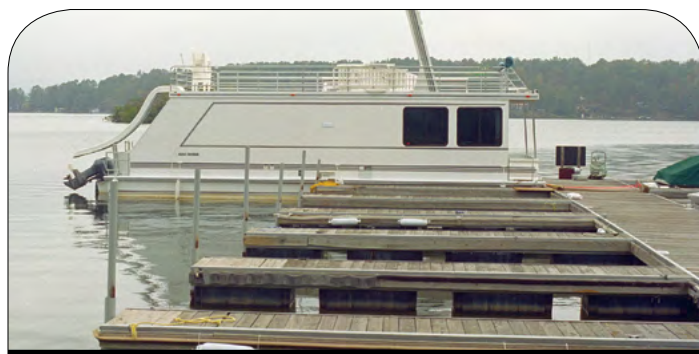
Photo 1. View of the subject houseboat docked in the marina.

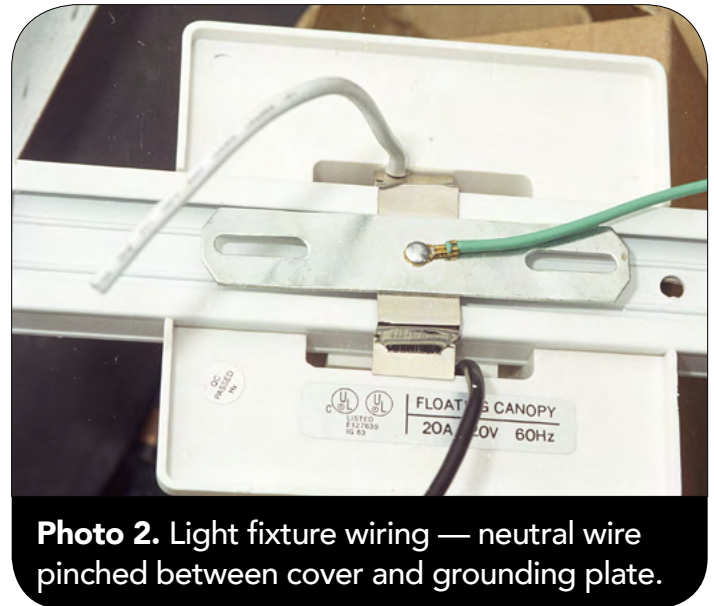
Further examination of the houseboat's electrical system and components exposed a faulty interior track lighting fixture. As shown in **Photo 2**, the neutral fixture wire was damaged as it passed out of the covered wiring compartment. Unless the fixture wires were correctly routed during the manufacturing process, the edges of the grounded mounting

plate would cut into the conductor insulation when the wiring compartment cover was installed. In this case, the neutral was effectively connected to electrical ground. The damaged “neutral,” in combination with the reversed polarity, created a dangerous situation. Under normal circumstances on a land-based electrical system, the fault current would have traveled to earth ground. Then, depending on several factors, including the circuit load, the location of the ground fault, and the condition of the ground connection, the rise in current would most likely have tripped the overcurrent protection. However, this did not occur.

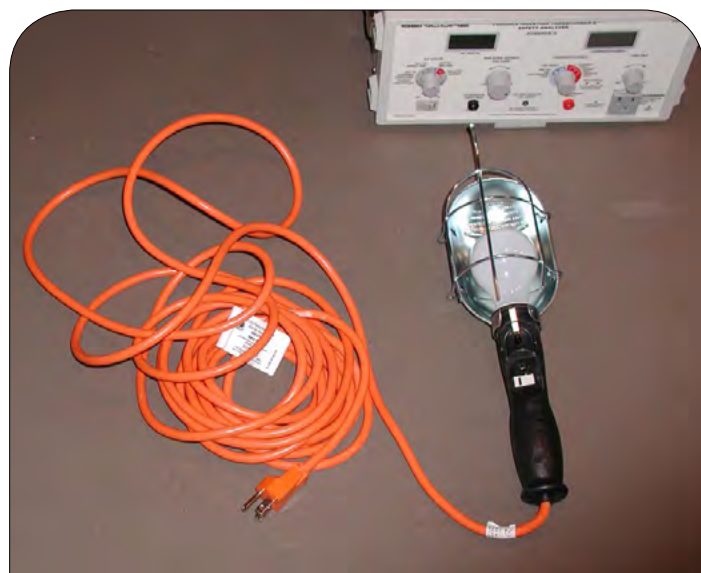
Photo 1. The hand lamp was plugged into a GFCI-protected bathroom receptacle via its attached 25-foot power cord, which was draped over the shower stall door.

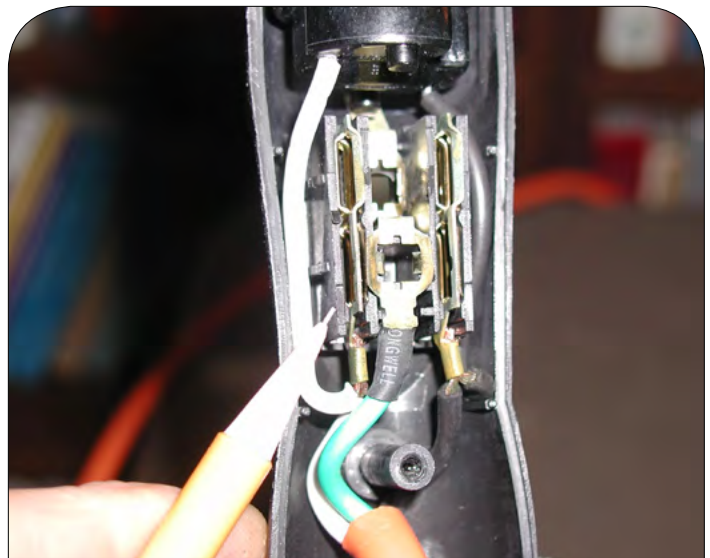
Photo 2. Not only was a screw missing that would have brought the guard assembly in connection with the grounding tab, deficient internal component spacing energized the entire lamp.

measurements between components and found why the lamp failed the test so quickly. The spacing between the integral receptacle’s grounding lug and neutral attachment was less than 0.04-inch, significantly less than the 0.25-inch specified in UL 298 (**Photo 2**). To make matters worse, the grounding lug for the receptacle could move and rotate to some degree, serving to further reduce the spacing. Inspection proved the deficiency was a design defect rather than a condition caused by deterioration or use of the appliance.

In addition, a missing screw allowed for a slight separation between the two halves of the upper part of the handle, exposing the internal components to dust, dirt, debris, water, and water vapor.

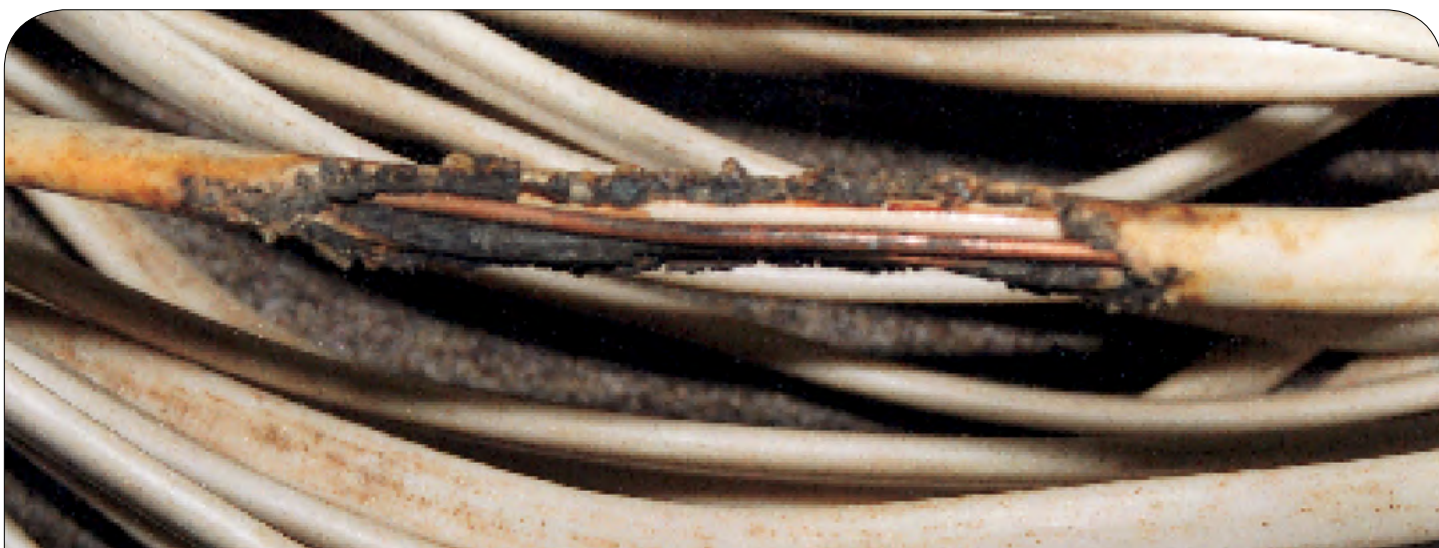
The damaged NM-B cable shows where the energized conductor came into contact with the grounding conductor.
