A LETHAL COMBINATION

*Real-world examples of why
electricity and water don't mix*

From the EC&M e-books library

Pool Shock Peril Resurfaces

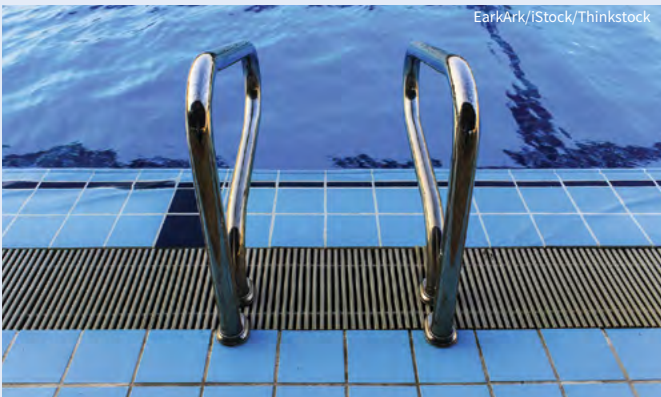
Pool Repairman Dies in Suspected Electrocution in Florida

This worker died from a suspected electrocution in Panama City Beach, Fla., when he and another coworker were repairing pool lights at a private residence. According to a report from the *News Herald*, one man was working at the breaker box while the other was in the pool when the accident occurred. <http://bit.ly/1v4u10u>

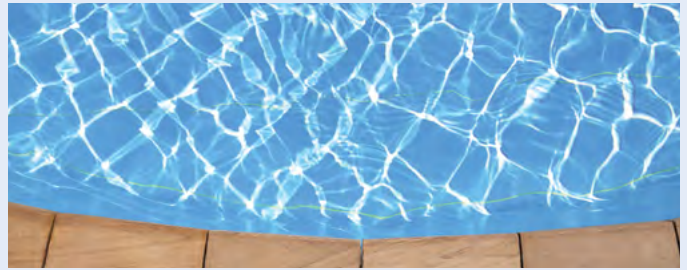
Pennsylvania Town Closes Pool After Shocks Reported

A town in Pennsylvania shut down its pool when a patron reported feeling electrical currents while sitting on the pool deck. The town council subsequently authorized \$75,000 in emergency repairs after the incident. According to a report from *Lehigh Valley Live*, electrical engineers said the pool deck was improperly bonded. <http://bit.ly/1rZKDZ4>

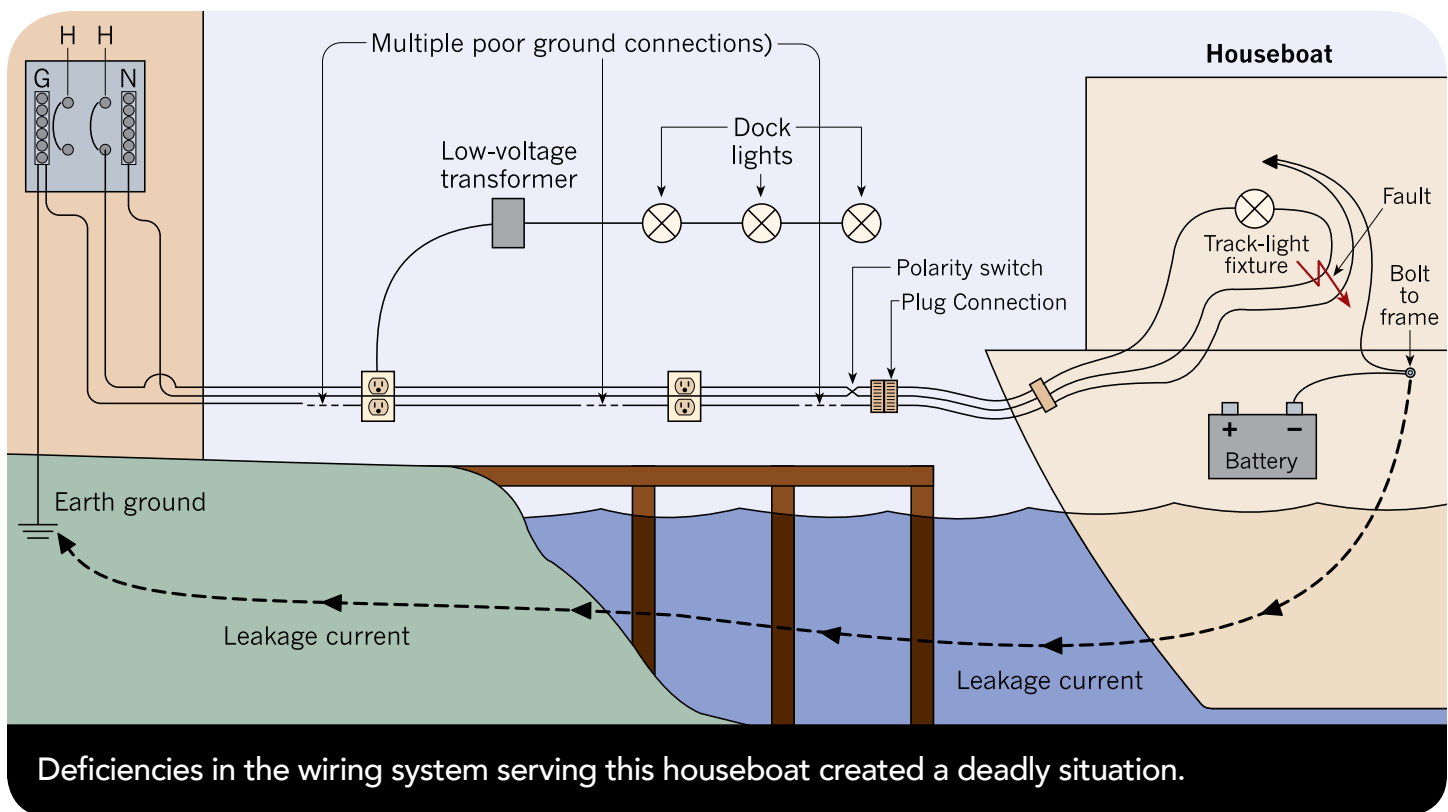
At the same time, Tim, the girl's father, grabbed onto a metal railing and leaned out over the water to grab Jenny. As he was leaning forward, he slipped into the water but still kept hold of the railing. Quickly, he felt his body painfully tighten and found that he could not release his hands. He was left hanging to the side of the boat in obvious pain. Although Cindy and Liz pleaded with him to let go, Tim told them in slow, contorted speech that he simply could not. Realizing that it might be an electrical problem, Dave ran to the front of the boat and unplugged it from shore power. This immediately allowed Tim to free his grip, and the others helped him back onto the rear deck. Soon thereafter, Jenny also was able to make it to the rear ladder and climb out of the water.

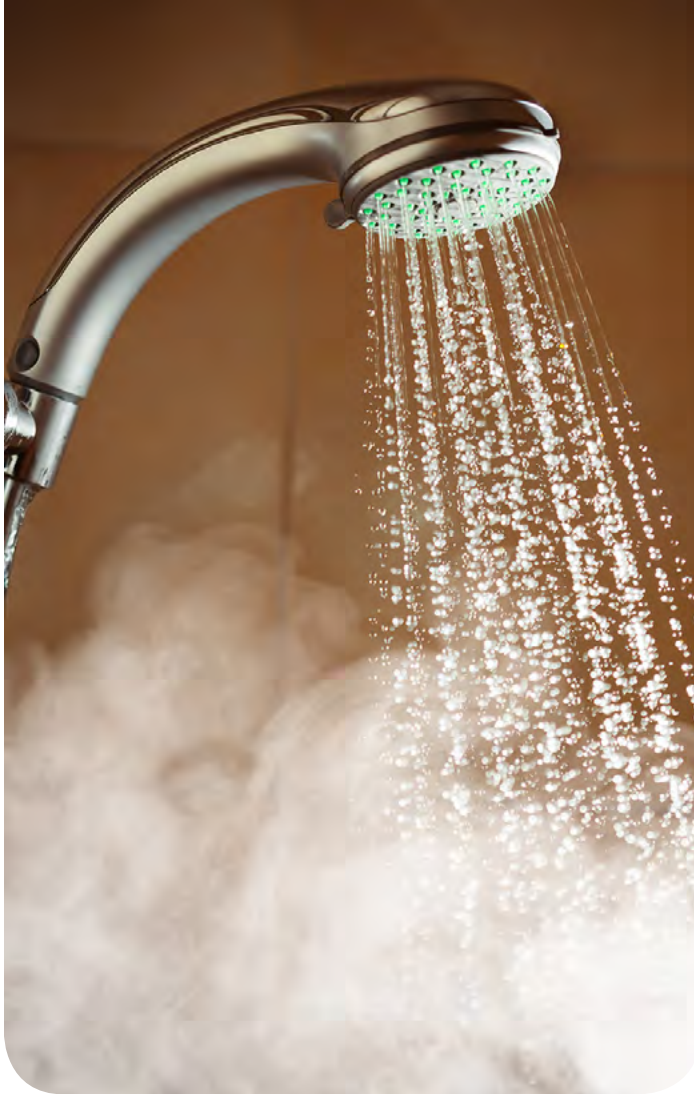
In addition, a missing screw allowed for a slight separation between the two halves of the upper part of the handle, exposing the internal components to dust, dirt, debris, water, and water vapor.

Non-compliance with the leakage criteria quickly surfaced as the primary critical factor in this incident. In order to evaluate leakage current, I energized the lamp at 120VAC and monitored the resulting

current flow to the lamp's grounding tab.

High ambient humidity, which would be found in a steamy bathroom like the one in question, affects ground leakage performance since water vapor can collect or condense on energized electric components and parts, which generally causes increased leakage current between inadequately spaced electrical connections or components.
